Flood and Ice Damage Study: Evaluation of 1970 and 2000 Rule Curves

Mike Shantz (Environment Canada)

**Submitted to the IJC for Review May 29th, 2015
Final Version to IJC July 12th, 2016**

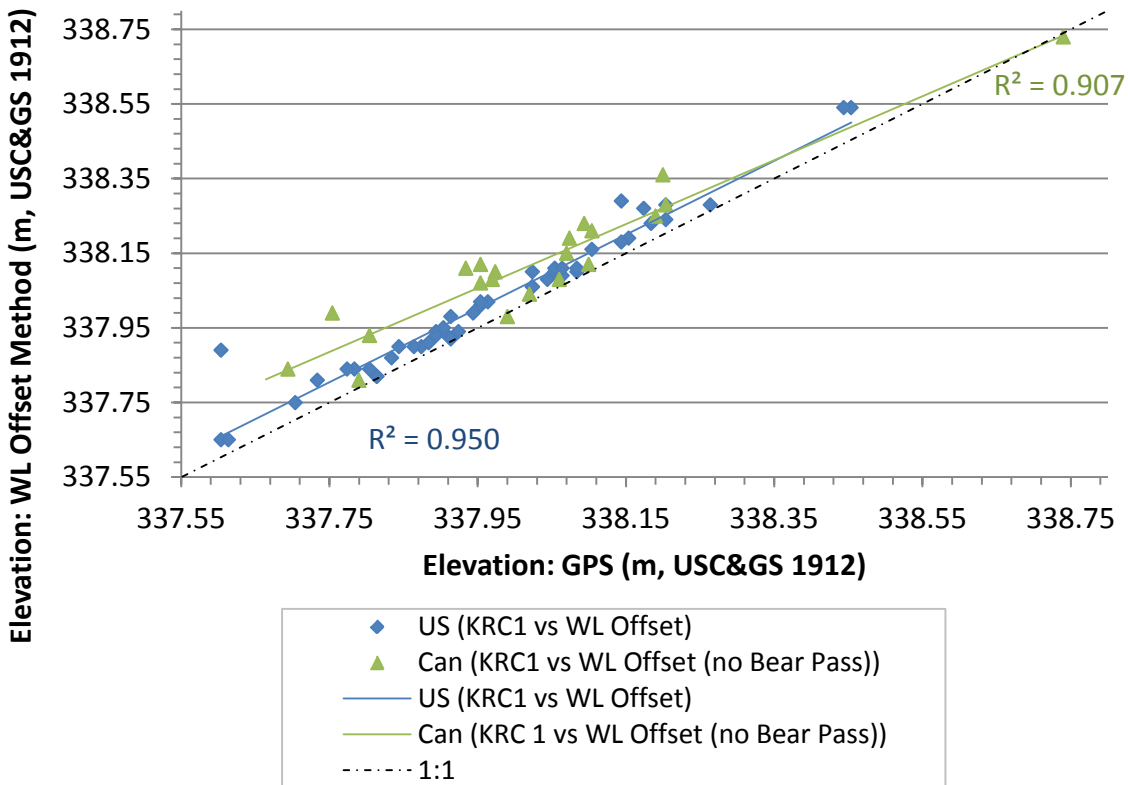
Figure 2-8: Comparison of KRC GPS elevation measurements and water level offset measurements for docks on Rainy Lake

approaches may have been associated with uncertainty in the individual measurement methods (e.g., GPS and water level offset), the conversions between the GPS datum and USC&GS 1912, or some combination. In the context of the flood study, the two independent approaches provided adequate and consistent results and were considered a reliable baseline to support flood damage assessments and to ground truth elevation extraction approaches from LiDAR and DEM data.

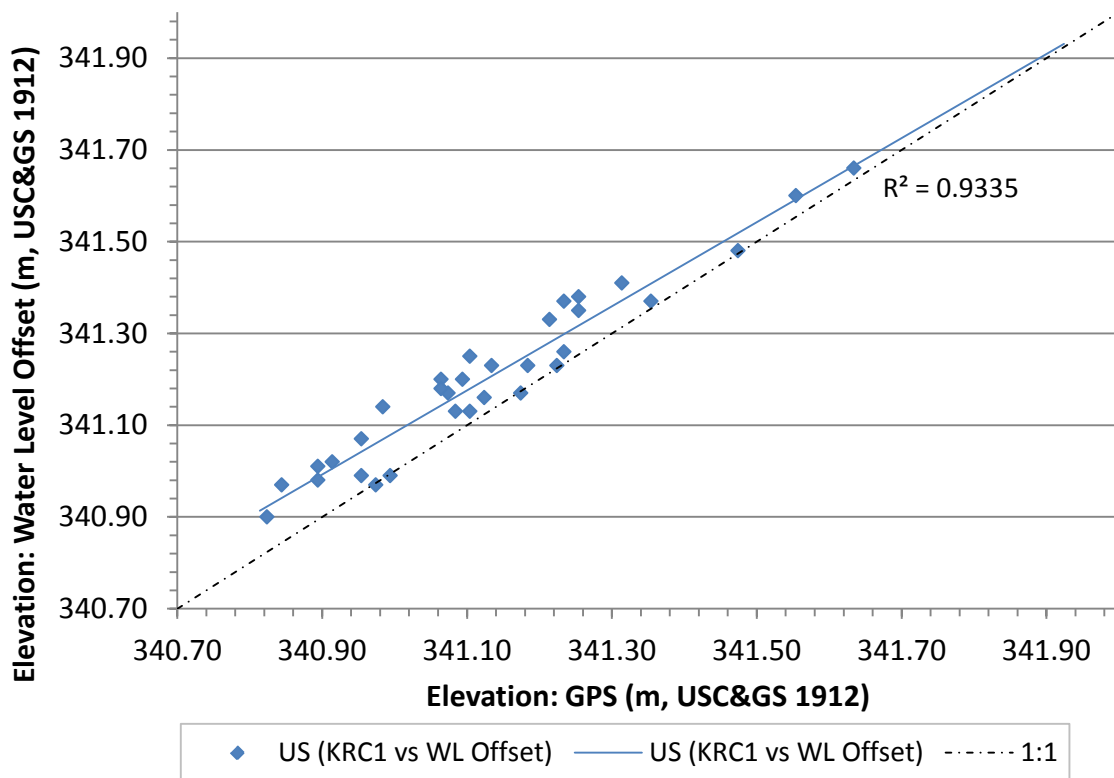
Figure 2-9: Comparison of KRC GPS elevation measurements and water level offset measurements for docks on Kabetogama Lake

For the Kabetogama Lake measurements (Figure 2-9), there was also a good relationship between the GPS measurements and the water level offset approaches with R^2 values of 0.9335. The water level offset values were on average 0.07 m higher than the respective GPS based measurement and the standard deviation of the differences was 0.05 m. As with the Rainy Lake results, the differences between the two approaches may have been associated with uncertainty in the individual measurement methods (e.g., GPS and water level offset), the conversions between the GPS datum and USC&GS 1912, or some combination. In the context of the flood study, the two independent approaches provided adequate and consistent results and were considered a reliable baseline to support flood damage assessments and to ground truth elevation extraction approaches from LiDAR and DEM data.

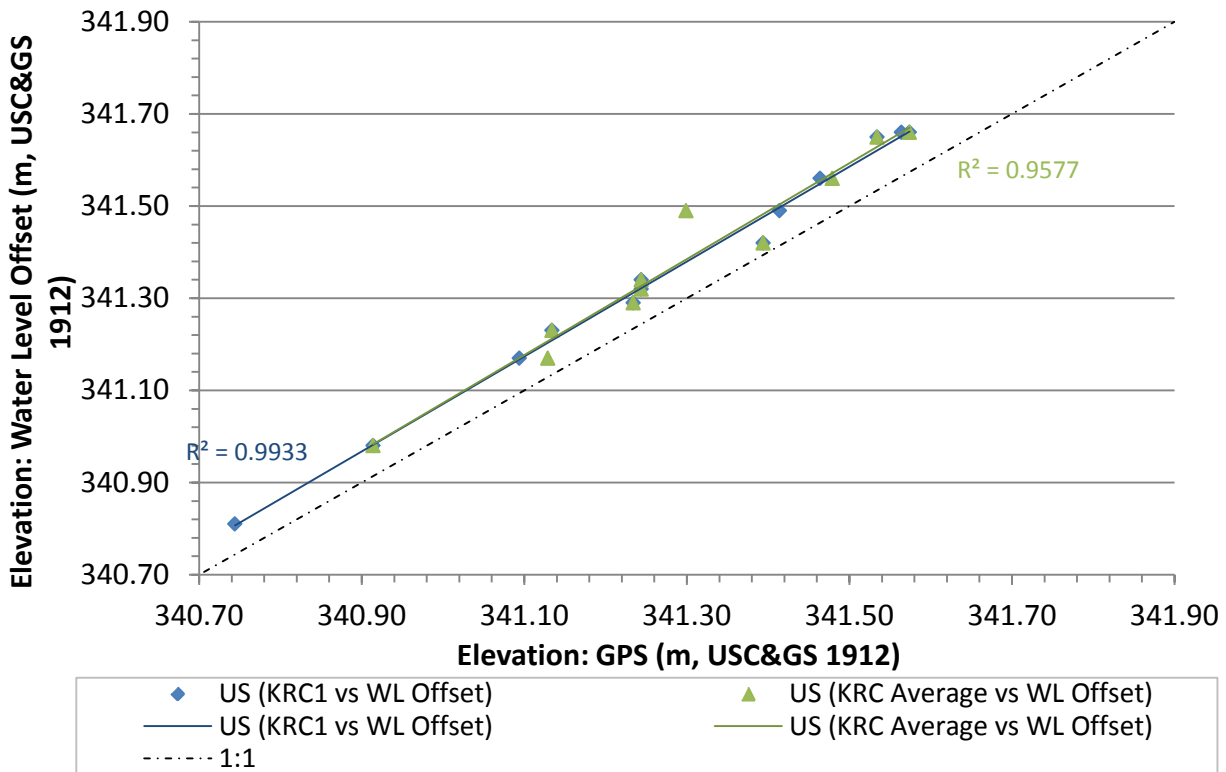
Figure 2-10: Comparison of KRC GPS elevation measurements and water level offset measurements for docks on Crane Lake

There was also a good relationship between the GPS measurements and the water level offset approaches on Crane Lake (Figure 2-10). Comparisons were made between the individual GPS points obtained by KRC (KRC1) and the water level offset values. A comparison was also made using average values (KRC average) if multiple GPS points were obtained for a single dock. In both cases, r^2 values were high (0.9933 and 0.9577 respectively). The water level offset values were on average 0.08 m higher than the respective GPS based measurement. When using the single KRC GPS points, the standard deviation was 0.04 m and when using the average of multiple GPS values, the standard deviation of the differences was 0.02 m. As with the Rainy Lake results, the differences between the two approaches may have been associated with uncertainty in the individual measurement methods (e.g., GPS and water level offset), the conversions between the GPS datum and USC&GS 1912, or some combination. In the context of the flood study, the two independent approaches provided adequate and consistent results and were considered a reliable baseline to support flood damage assessments and to ground truth elevation extraction approaches from LiDAR and DEM data.

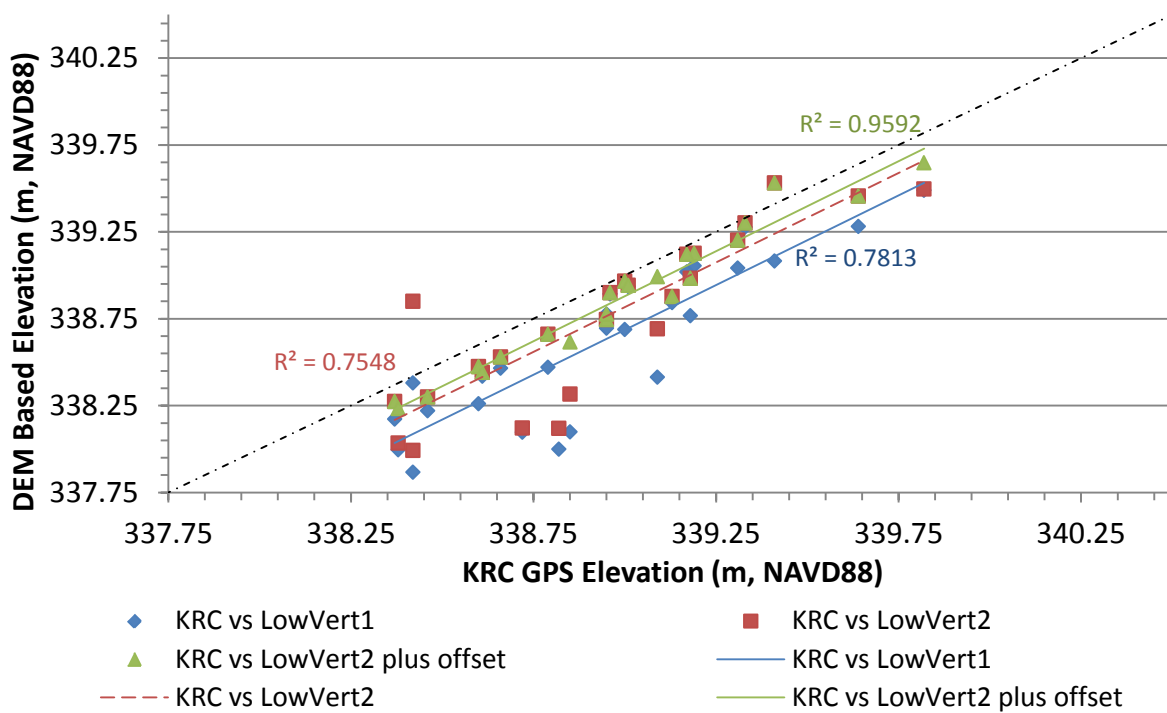
Figure 2-12: Comparison of KRC elevation measurements and DEM based estimates for buildings on Rainy Lake (US) shoreline

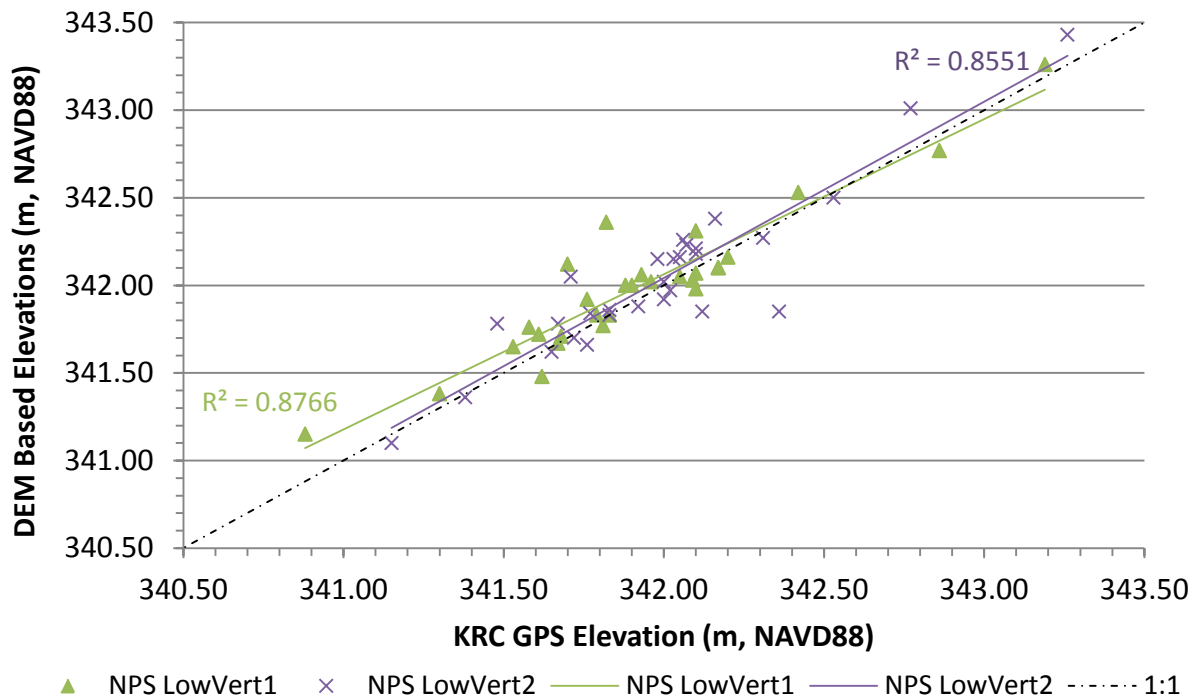
Figure 2-14: Comparison of KRC elevation measurements and National Park Service (NPS) DEM based estimates for buildings on Kabetogama Lake (US) shoreline

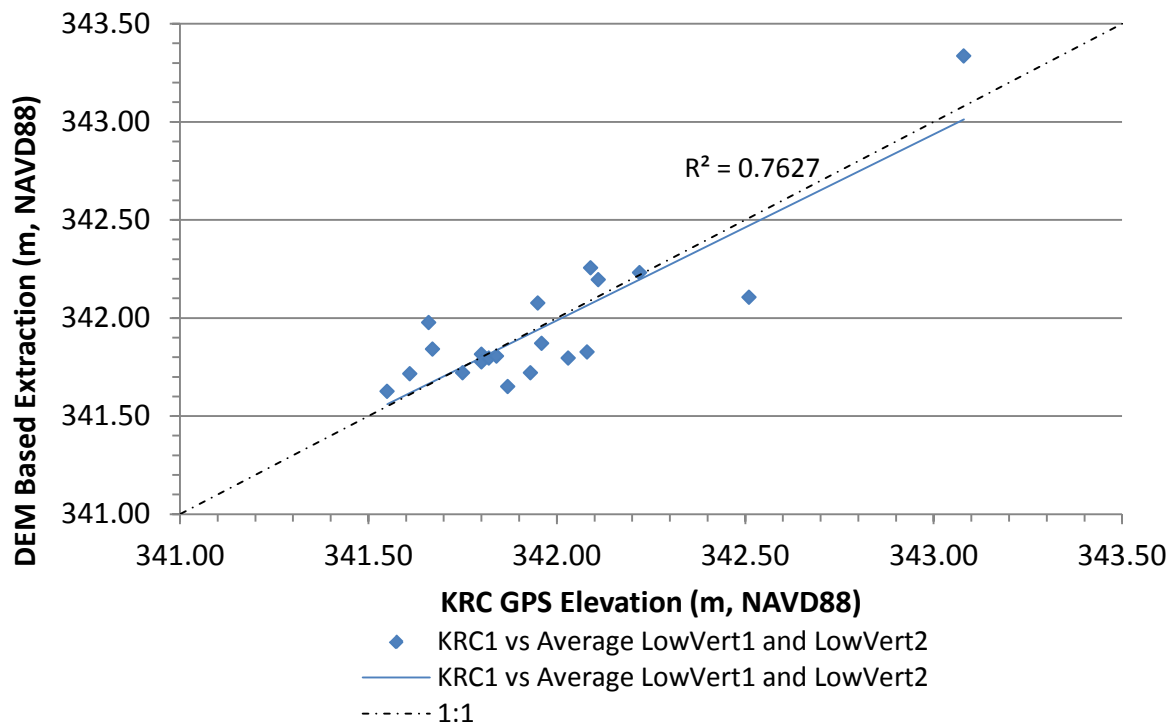
Figure 2-15: Comparison of KRC elevation measurements and DEM based estimates for buildings on Crane Lake (US) shoreline

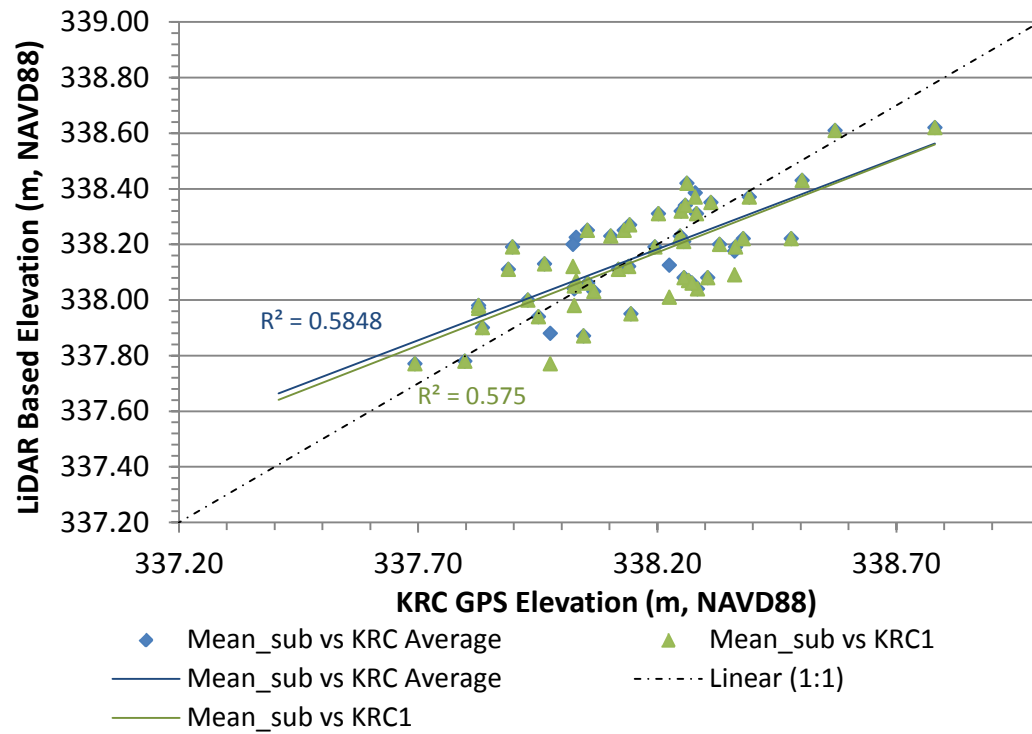
Figure 2-16: Comparison of GPS and LiDAR Based Dock Elevation Estimates - Rainy Lake

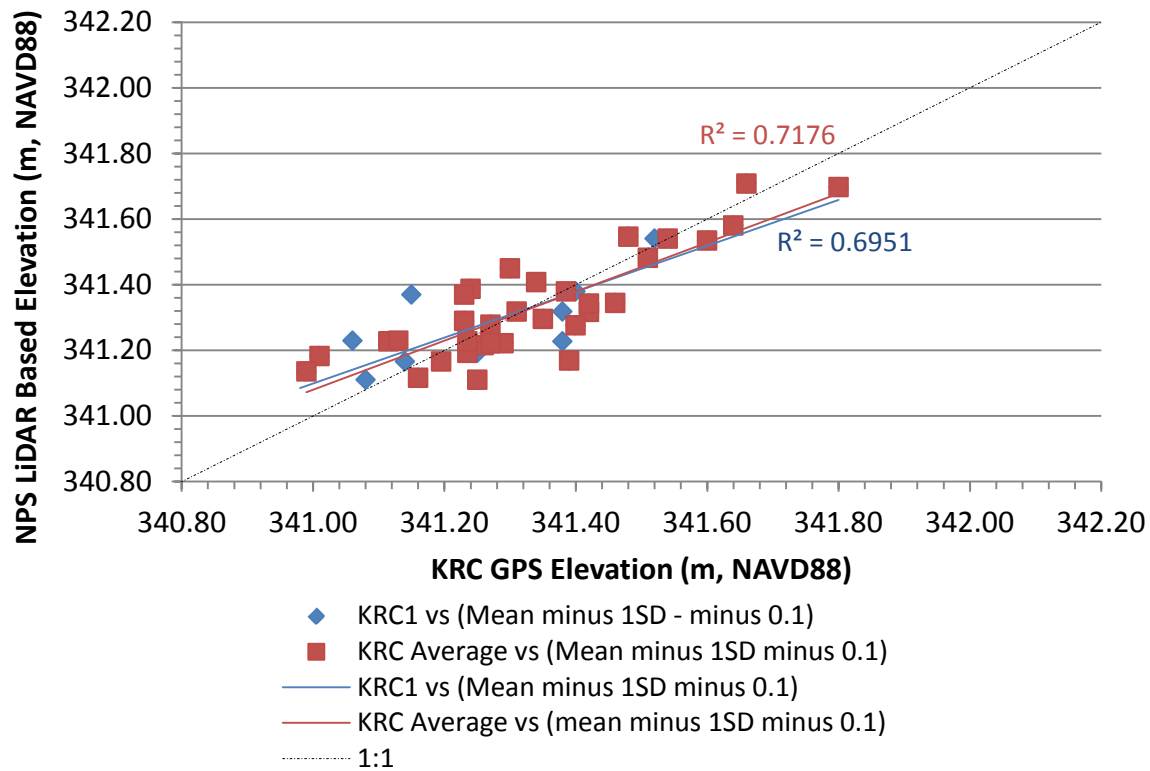
Figure 2-17: Comparison of GPS and National Park Service (NPS) LiDAR Based Dock Elevation Estimates - Kabetogama Lake

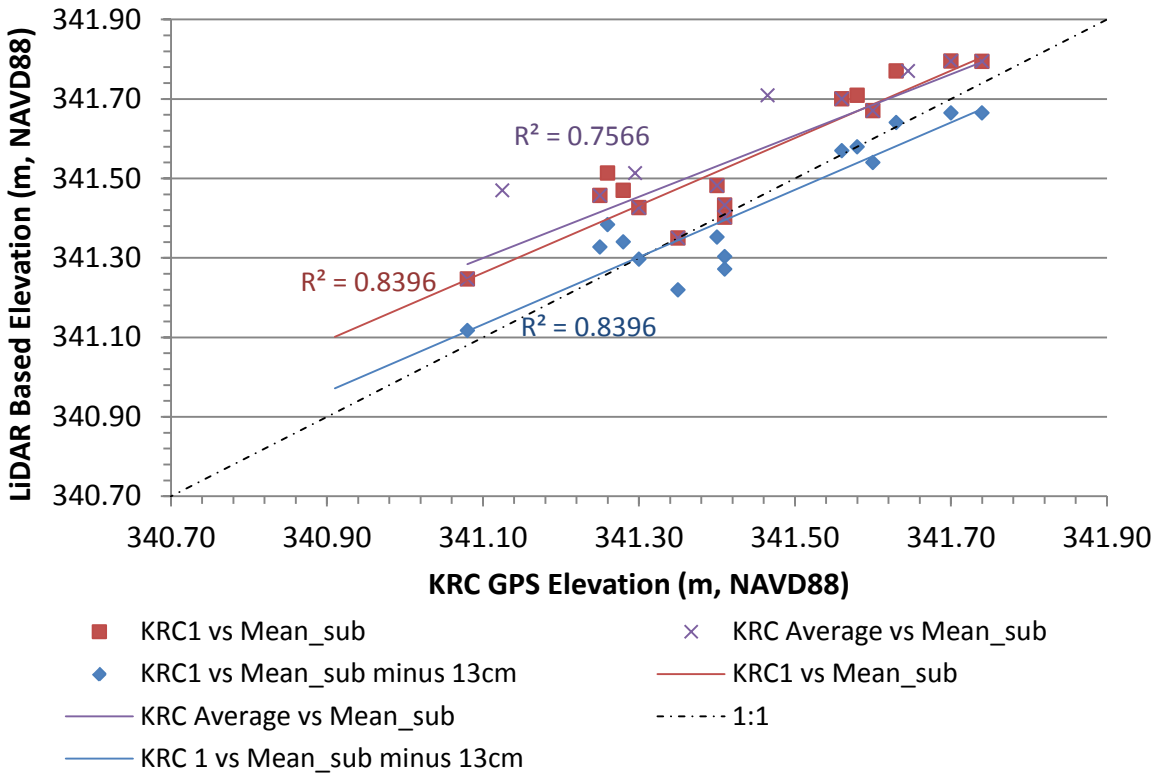
Figure 2-18: Comparison of GPS and LiDAR Based Dock Elevation Estimates – Crane Lake
