# *2016-2017 Operation of the Lake Erie - Niagara River Ice Boom*

*A report to the International Niagara Board of Control by the  
International Niagara Working Committee*

*October 2017*

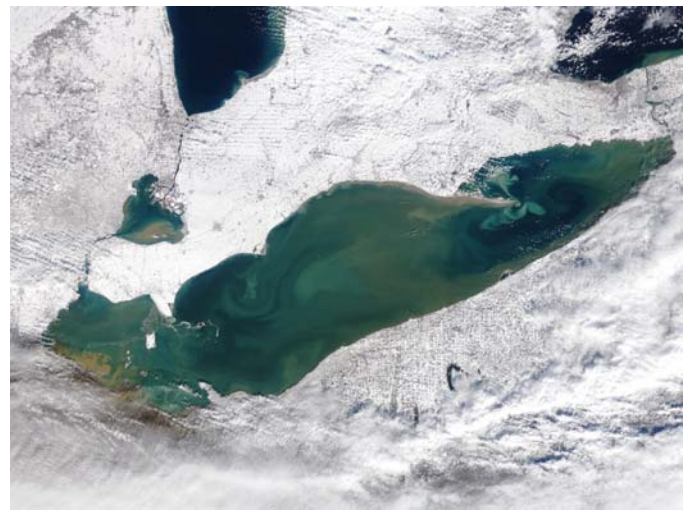
Figure 1: MODIS Satellite Imagery from the (NOAA) Coast Watch Great Lakes Program, 1 February 2017

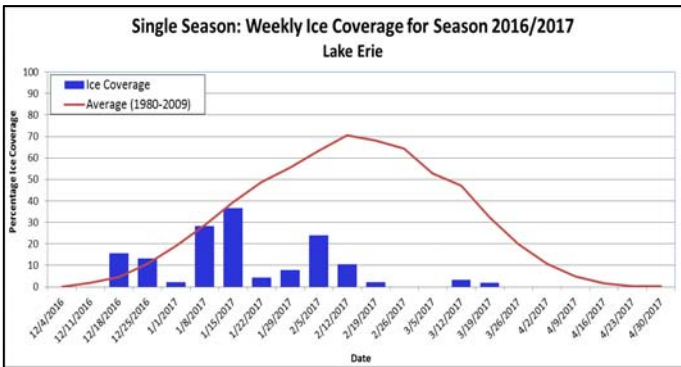
Figure 2: Single Season: Weekly Ice Coverage for 2016/17 provided by the Canadian Ice Service

The first ice of the season was observed in the Chippewa Grass Island Pool on 8 January 2017. As shown in Figure 2, ice coverage on Lake Erie peaked at 37 percent mid-January as reported by the Canadian Ice Service. Figure 3 displays the extreme difference in ice coverage for Lake Erie over the last four years beginning with the 2013/14 ice season thru the 2016/17 ice season.

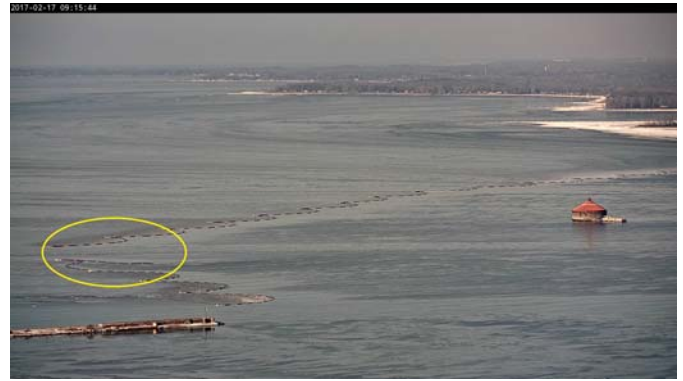
On 10 February 2017 Span E was observed to be open and trailing as shown in Figure 5 (circled in yellow). NYPA crews completed repairs to Span E on 17 February 2017. A thorough inspection was completed following the repairs and all sections of the Lake Erie-Niagara River Ice Boom were shown to be in good working order.

Figure 5: Span E is circled in yellow, shown open and trailing. Image courtesy of NYPA from the Lake Erie-Niagara River Ice Boom webcam.

On 10 February 2017 Span E was determined to be open and trailing. NYPA crews completed repairs on 17 February.

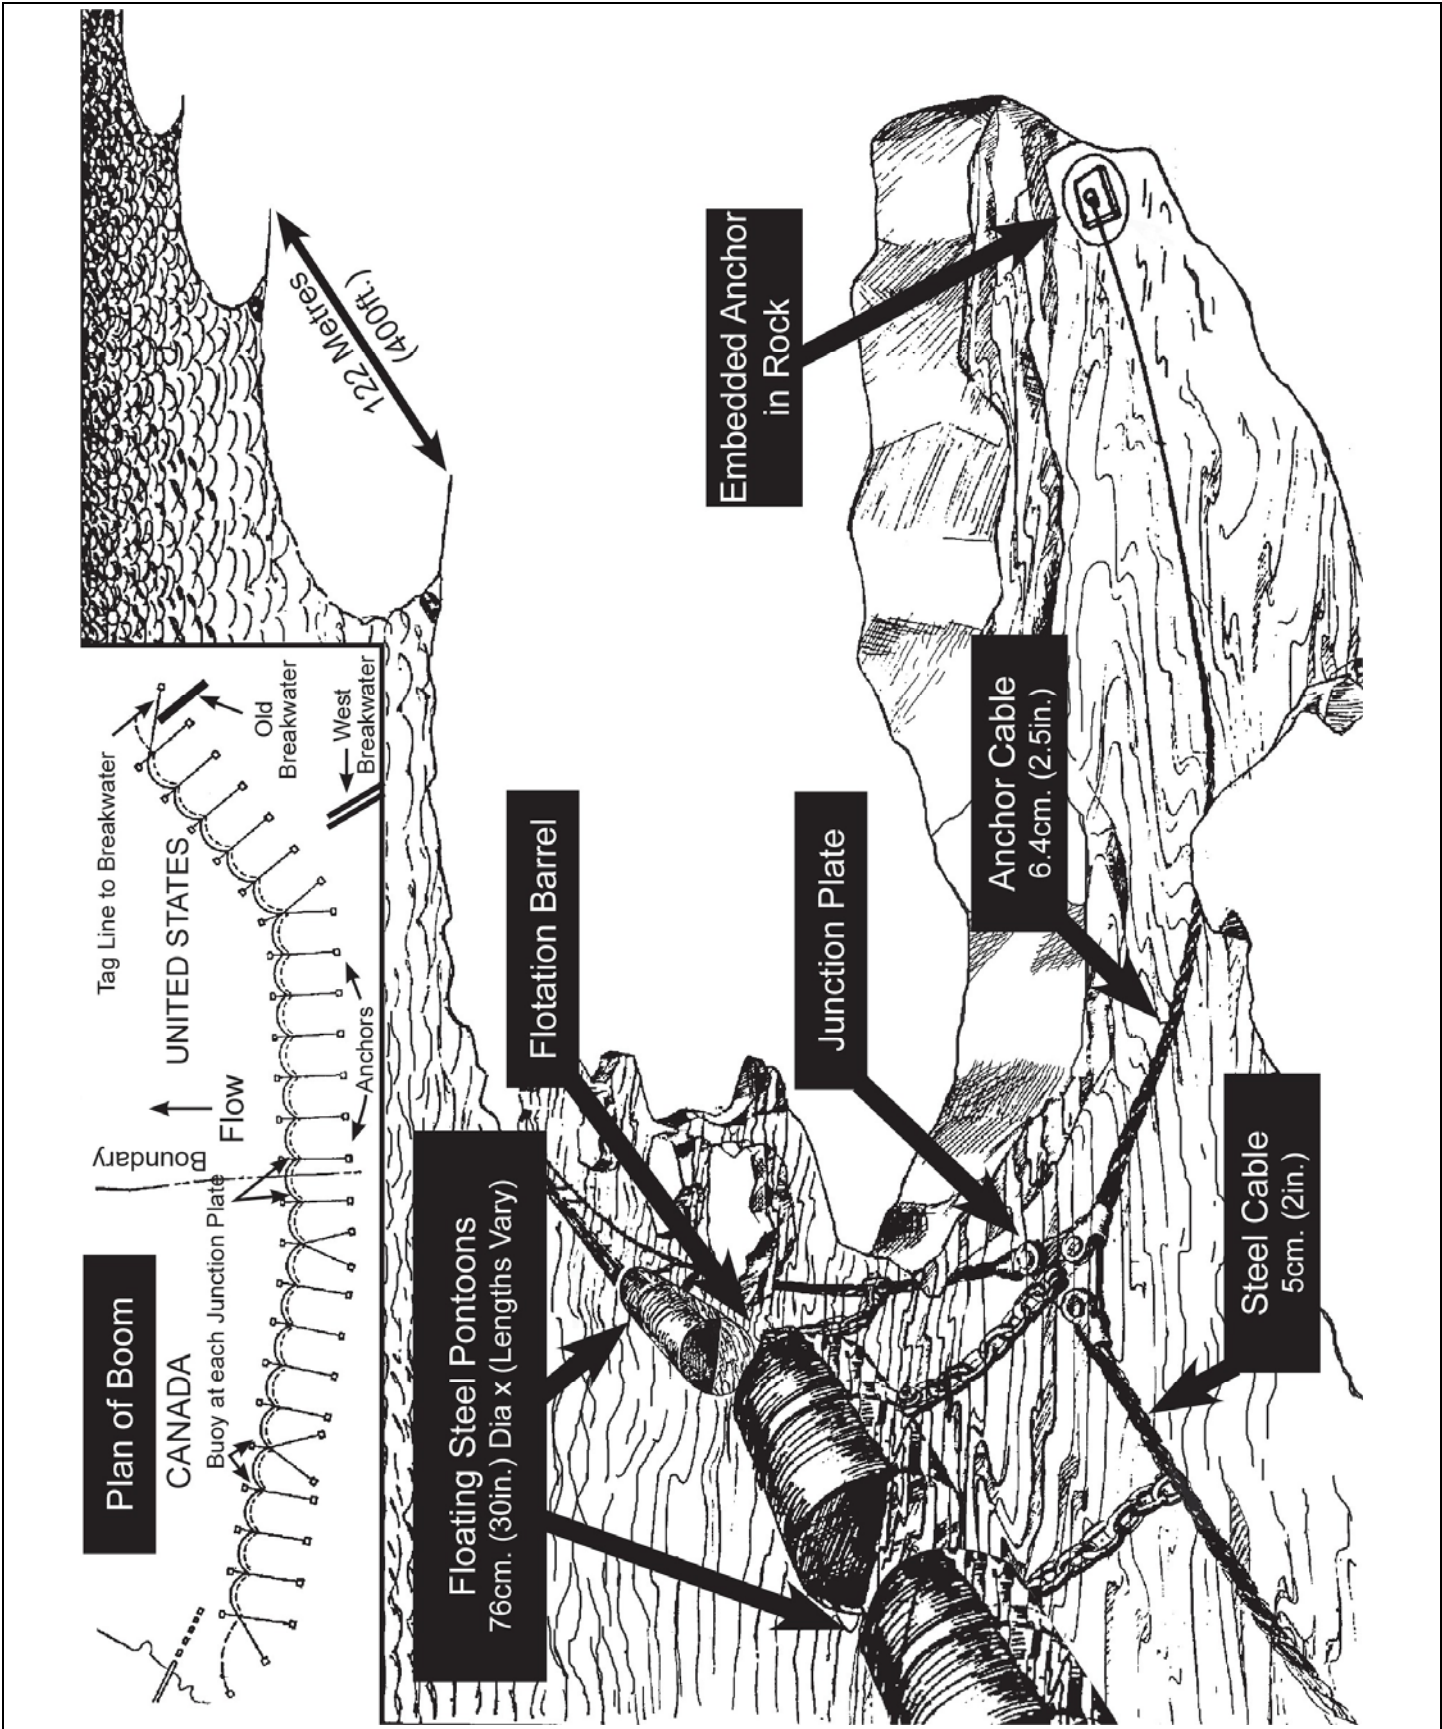
Enclosure 5: Ice Boom Detail

When in position, the 2,700 m (8,800 ft) ice boom spans the outlet of Lake Erie and is located approximately 300 m (1,000 ft) southwest of the water intake crib for the city of Buffalo. The boom is made up of 22 spans. Spans are anchored to the lake bed at 122 m (400 ft) intervals by 6.4 cm (2.5 in) diameter steel cables. Enclosure 5 illustrates structural details and a plan view of the ice boom is shown in Enclosure 6. As a result of studies conducted by the Power Entities, all of the timber pontoons were replaced with 76 cm (30 in) diameter, 9 m (30 ft) long steel pontoons. This replacement was done to improve the ice-overtopping resistance of the ice boom and reduce its maintenance costs. The replacement of timbers with steel pontoons was completed in the fall of 1997 and the first all-steel-pontoon ice boom was used in the 1997-98 ice season.

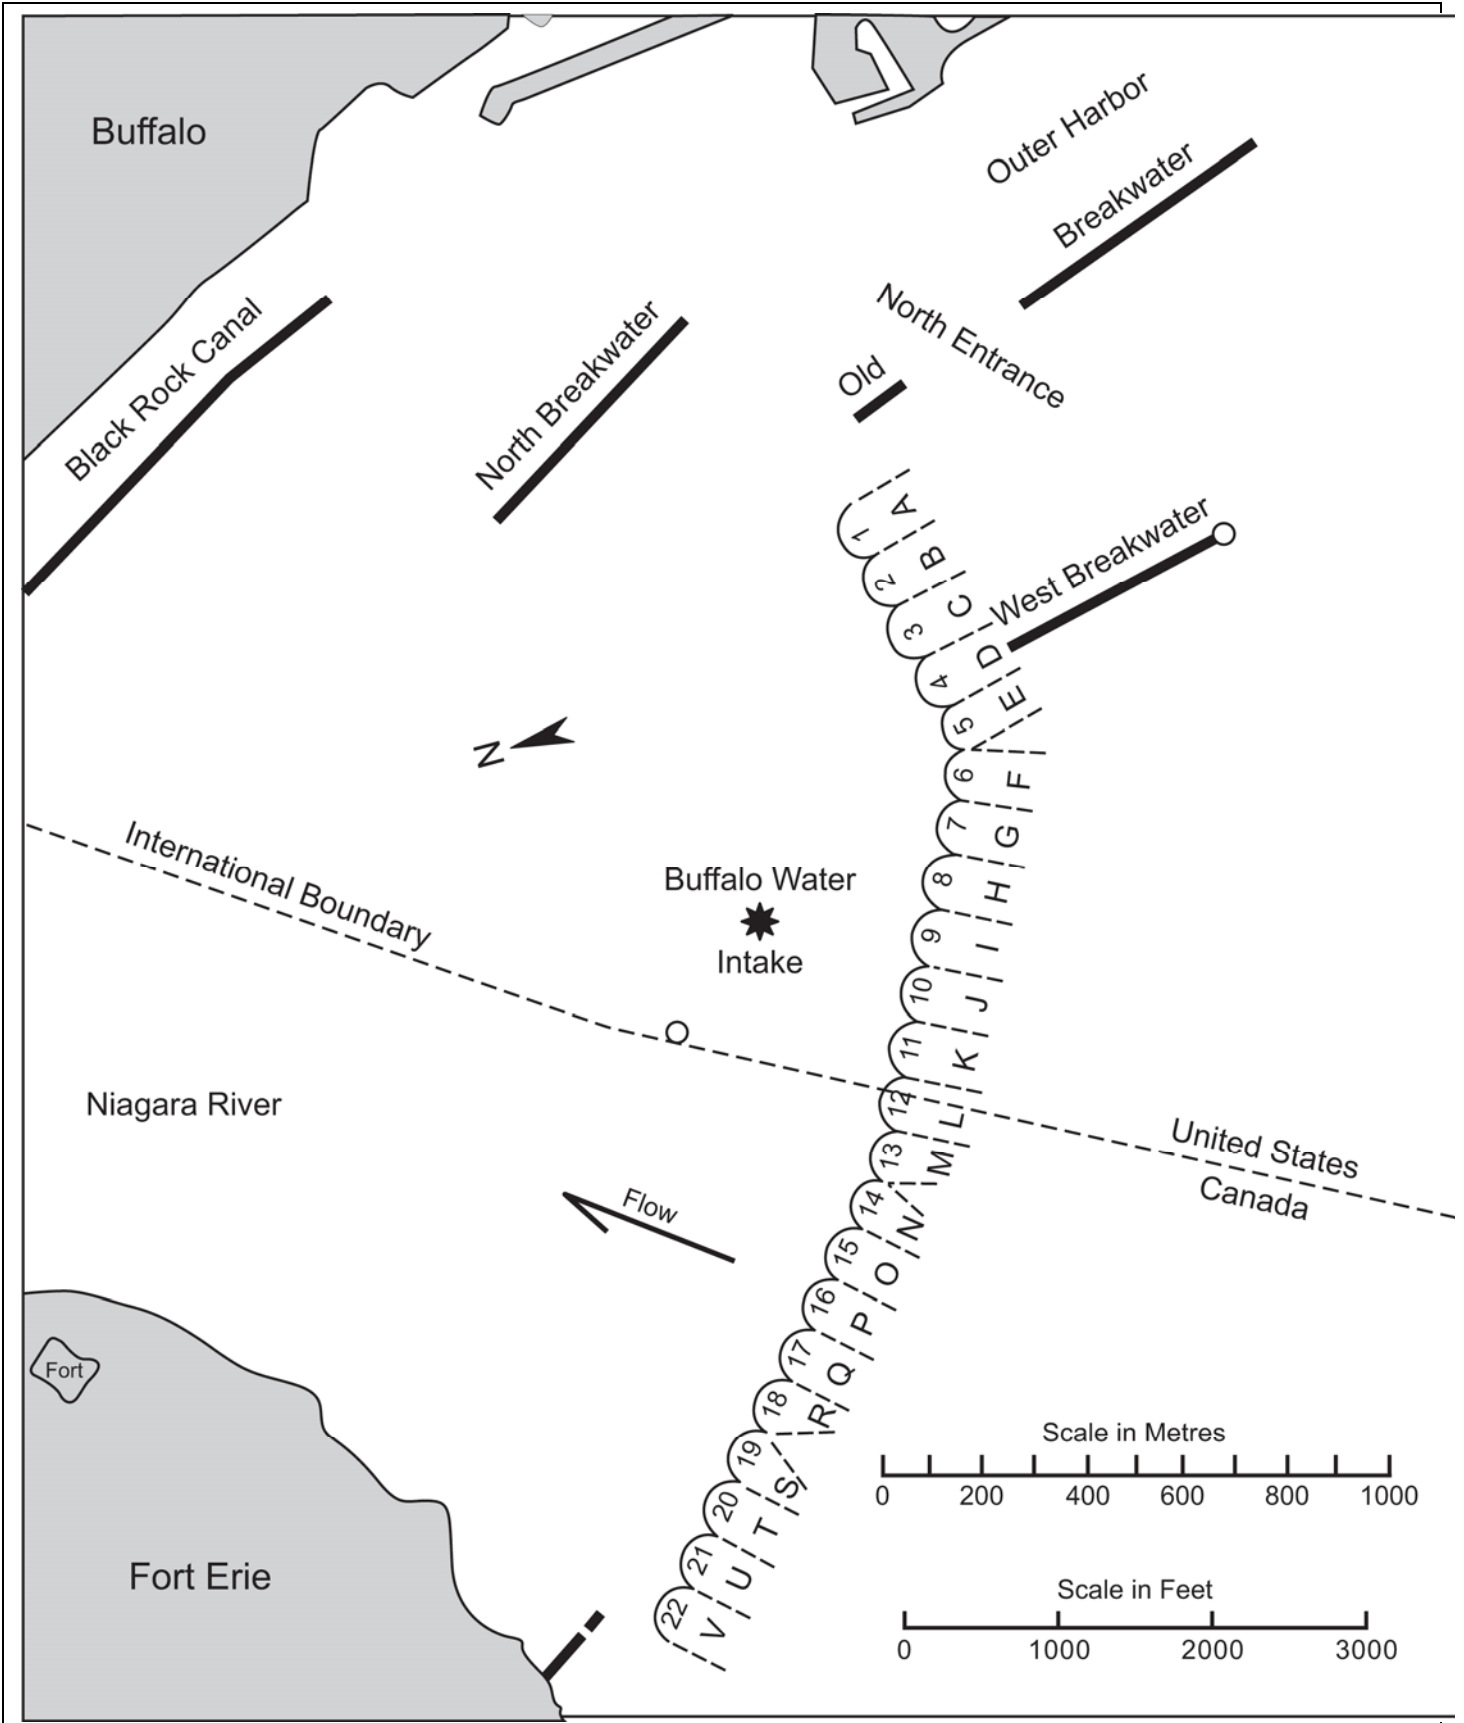
Enclosure 6: Plan View of Ice Boom

Lake Erie water temperature dropped to 4°C (39°F) on 15 December 2016. The following day, 16 December 2016, the Board issued a media advisory that installation of the Lake Erie-Niagara River Ice boom would begin that day. Due to inclement weather conditions, installation began the following day. On 17 December 2016 crews installed 7 spans (Spans V to P) on the Canadian Side of the Niagara River (refer to Enclosure 6 for span layout).

Enclosure 6 shows the plan view of the ice boom on Lake Erie. Enclosure 7 shows the span configuration using the typical 9 m (30 ft) pontoon and the 4.6 m (15 ft) mini pontoons.

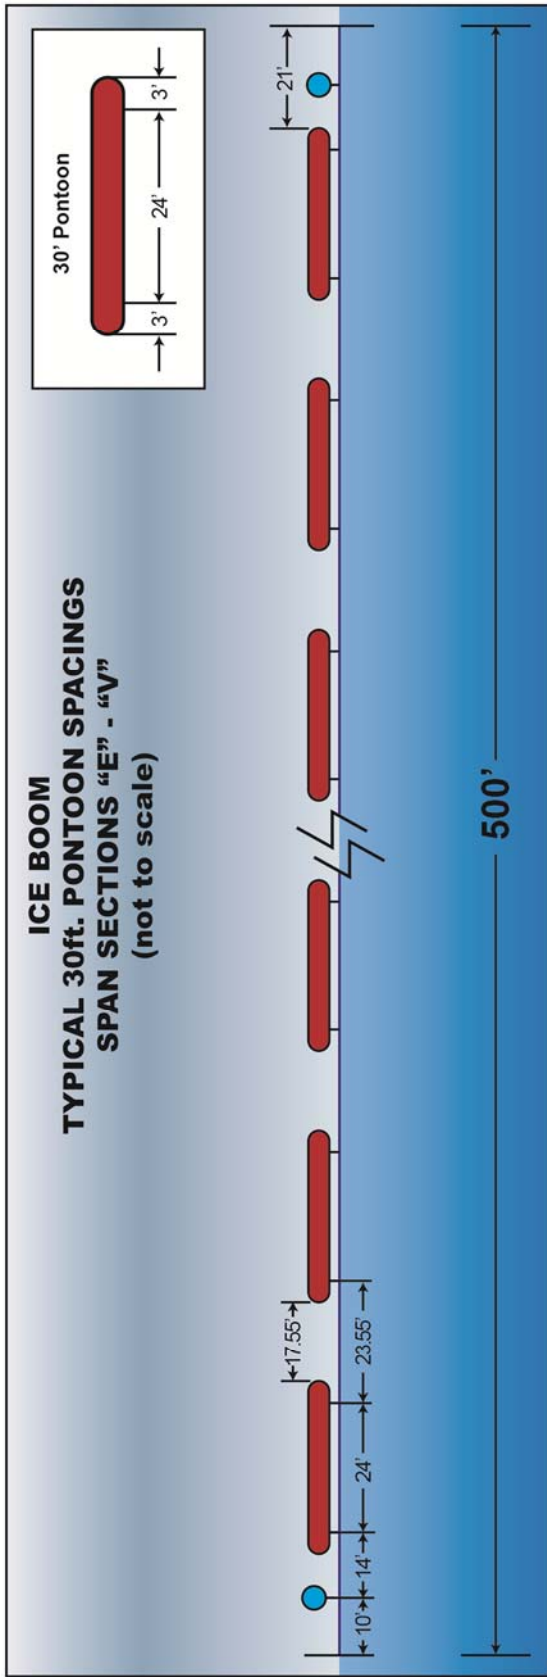
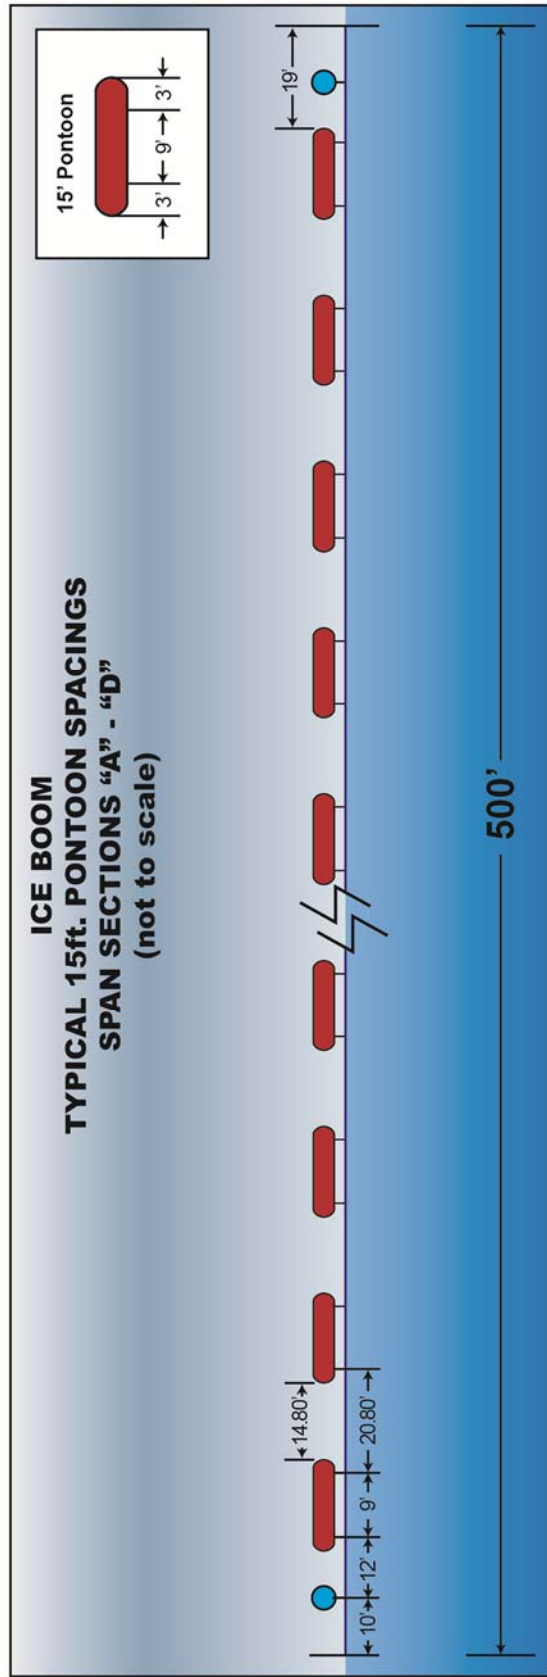
Enclosure 7: Typical Pontoon Spacing and Lengths

To further reduce the pontoon end cap damage and reduce the fatigue of the span cables between the inner and outer break walls (i.e. Spans A through D), the number and length of pontoons were changed to sixteen 4.6 m (15 ft) long mini pontoons per 152 m (500 ft) span, during the 2000-01 ice season. As per maintenance protocol, and to further reduce damage to the ends of the pontoons, sections K-P were reduced from 11 to 10 pontoons per sections at the start of the 2001-02 ice season. Remaining sections Q-V were reconfigured to 10 pontoons per span at the beginning of the 2002-03 ice season.
