2019-2020 Operation of the Lake Erie-Niagara River Ice Boom

A report to the International Niagara Board of Control by
the International Niagara Working Committee

October 2020

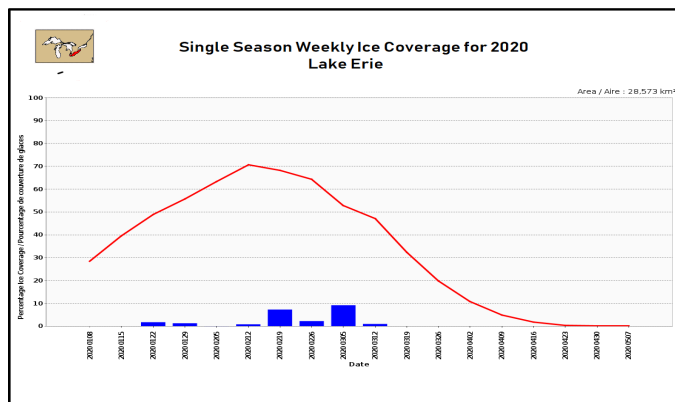
Figure 2: Single Season: Weekly Ice Coverage for 2019-2020 provided by the Canadian Ice Service

The first ice of the season was observed in the Chippewa Grass Island Pool (CGIP) on 21 February 2020. As shown in Figure 2, Lake Erie remained almost ice free, with minimal amounts of shore ice during the winter of 2019-2020. Ice coverage peaked at 9% the first several days of March before quickly dissipating for the season. The INWC deemed the two routine helicopter flights for ice thickness measurements, and one fixed wing flights for lake ice area assessment in the eastern basin of Lake Erie,

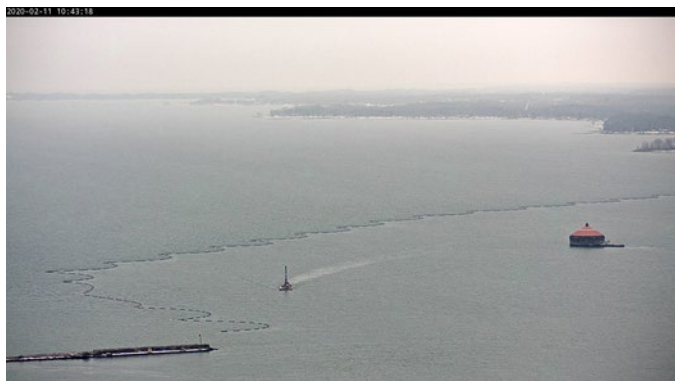
Figure 4: View from the NYPA Ice Boom Camera, 11 February 2020

High winds events on 12 and 18 January tested the integrity of the ice boom. The only damage reported for the ice season of 2019 – 20 was a trailing pontoon at Span M, the closest span to the Canadian shoreline. NYPA crews repaired Span M on 19 February 2020. NYPA crews at work can be seen from ice boom camera (Figure 4).

On 17 February 2020 ice boom crews located a break due to high winds at Span M. The span was repaired on 19 February 2020.

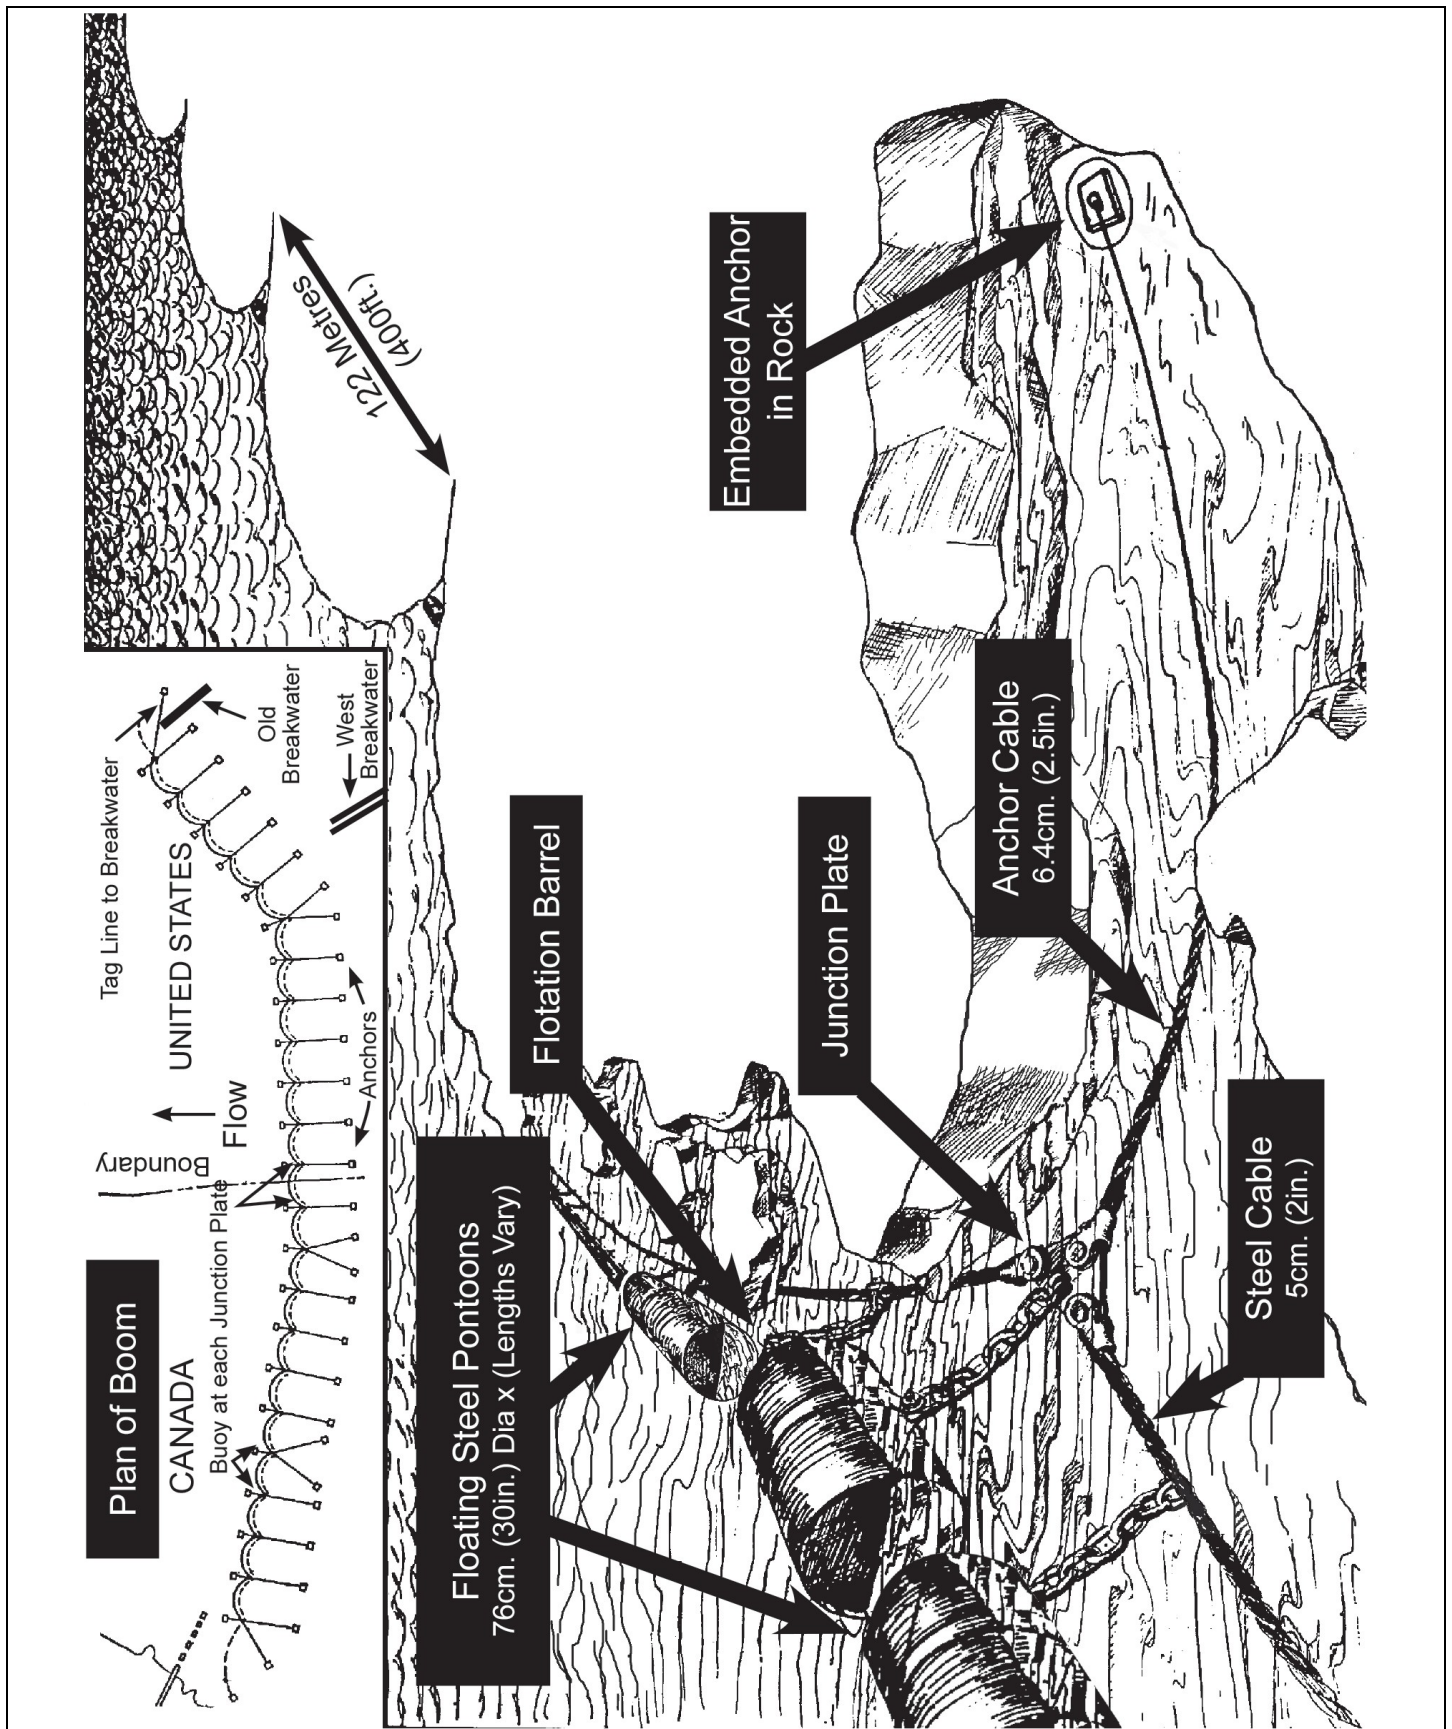
Enclosure 5: Ice Boom Detail

When in position, the 2,700 m (8,800 ft) ice boom spans the outlet of Lake Erie and is located approximately 300 m (1,000 ft) southwest of the water intake crib for the city of Buffalo. The boom is made up of 22 spans. Spans are anchored to the lake bed at 122 m (400 ft) intervals by 6.4 cm (2.5 in) diameter steel cables. Enclosure 5 illustrates structural details and a plan view of the ice boom is shown in Enclosure 6. As a result of studies conducted by the Power Entities, all of the timber pontoons were replaced with 76 cm (30 in) diameter, 9 m (30 ft) long steel pontoons. This replacement was done to improve the ice-overtopping resistance of the ice boom and reduce its maintenance costs. The replacement of timbers with steel pontoons was completed in the fall of 1997 and the first all-steel-pontoon ice boom was used in the 1997-98 ice season.

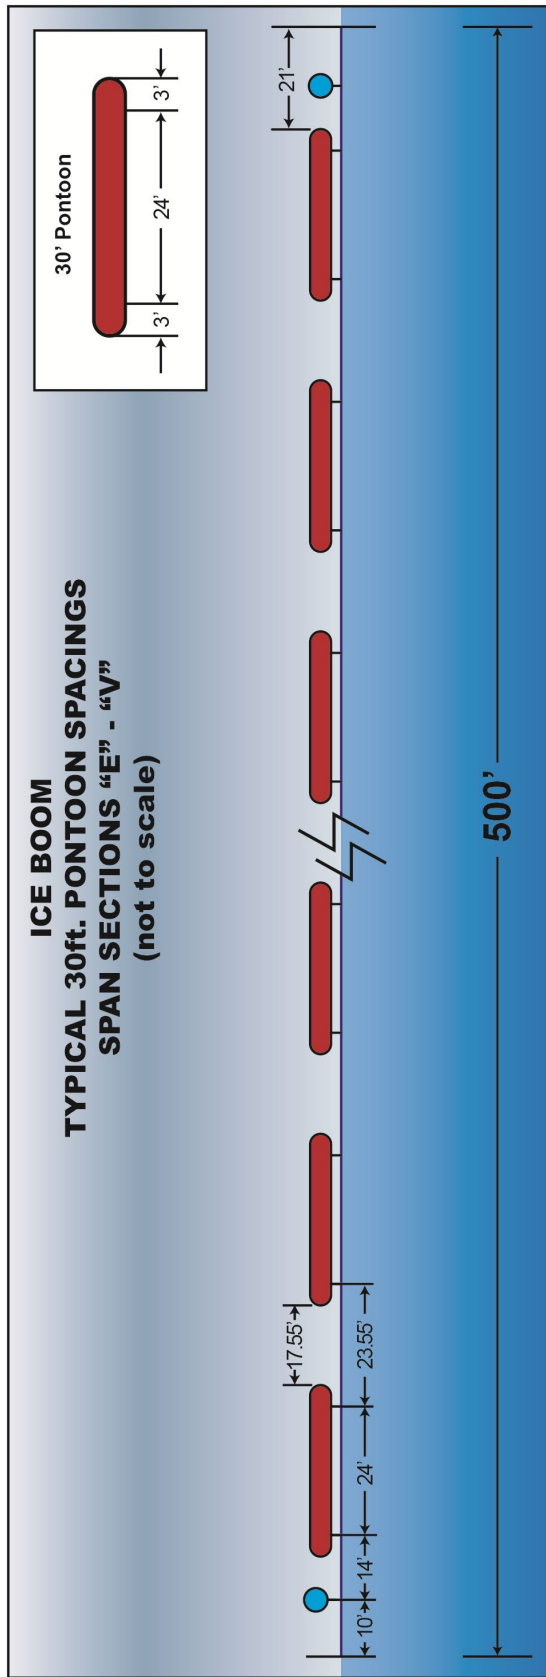
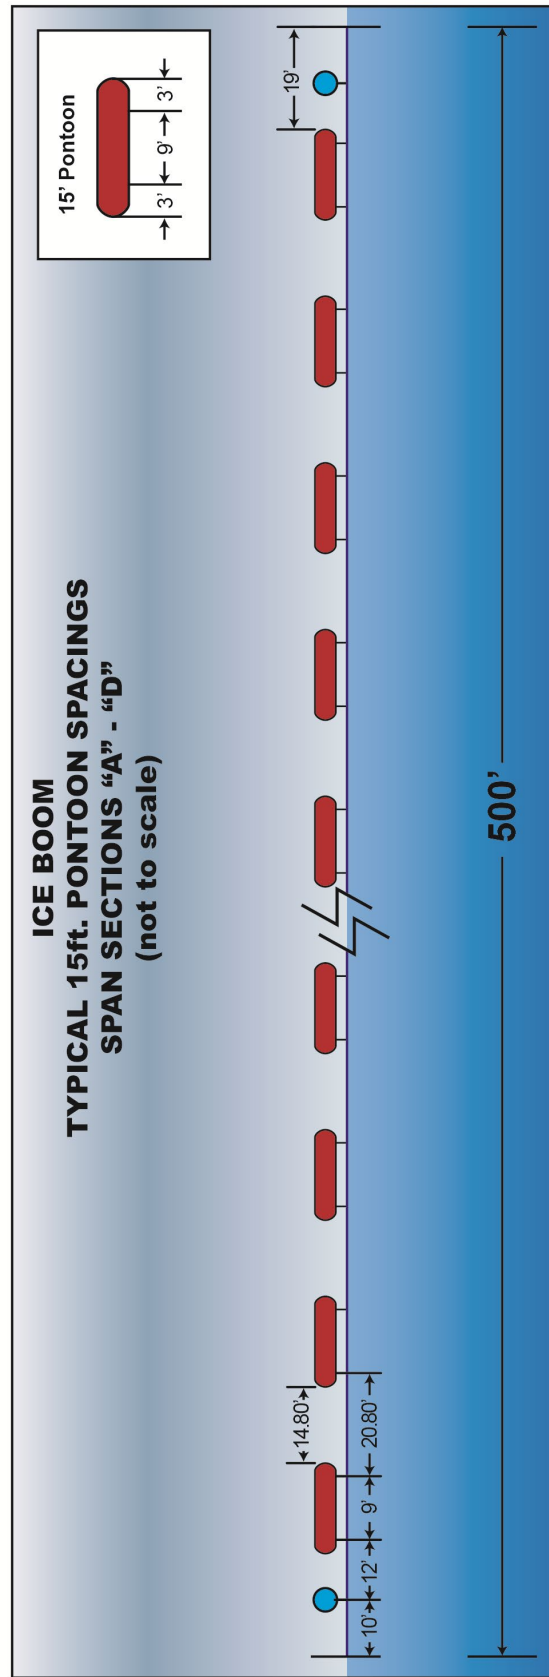
To further reduce the pontoon end cap damage and reduce the fatigue of the span cables between the inner and outer break walls (i.e. Spans A through D), the number and length of pontoons were changed to sixteen 4.6 m (15 ft) long mini pontoons per 152 m (500 ft) span, during the 2000-01 ice season. As per maintenance protocol, and to further reduce damage to the ends of the pontoons, sections K-P were reduced from 11 to 10 pontoons per sections at the start of the 2001-02 ice season. Remaining sections Q-V were reconfigured to 10 pontoons per span at the beginning of the 2002-03 ice season.

Enclosure 6 shows the plan view of the ice boom on Lake Erie. Enclosure 7 shows the span configuration using the typical 9 m (30 ft) pontoon and the 4.6 m (15 ft) mini pontoons.
