FISH CONVEYANCE AND MIGRATION IN THE INTERNATIONAL ST. CROIX RIVER

PREPARED FOR THE INTERNATIONAL
JOINT COMMISSION

MARCH 2018

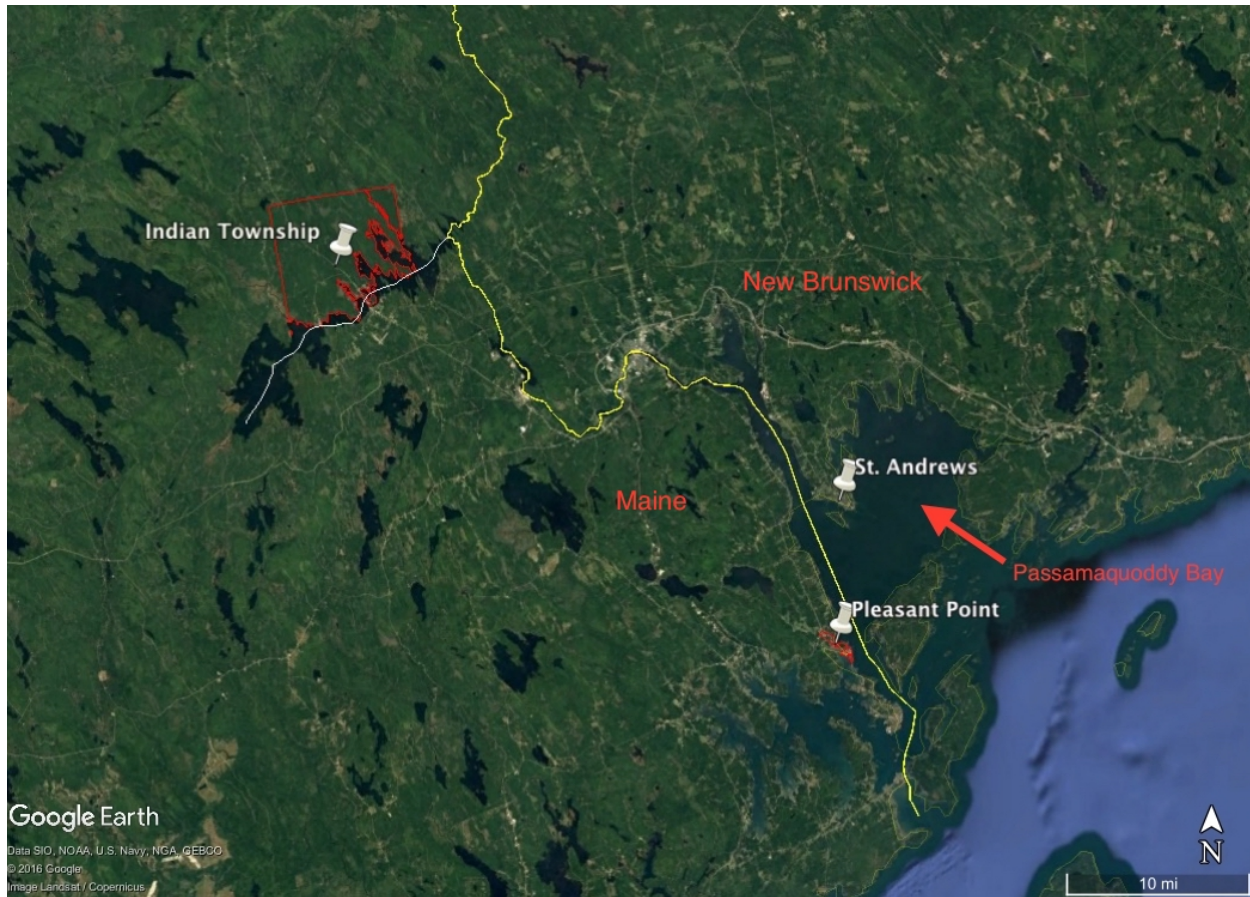
Figure 4: Locations of the Passamaquoddy Reservations at Pleasant Point, Indian Township, and St. Andrews, in relation to the St. Croix River (yellow line). The St. Croix River forms the border between the U.S.A. and Canada (yellow line), prior to its split into two branches at Kellyland, ME. Indian Township rests on the shores of the West Branch (white line). The East Branch of the St. Croix River continues to follow the international border.

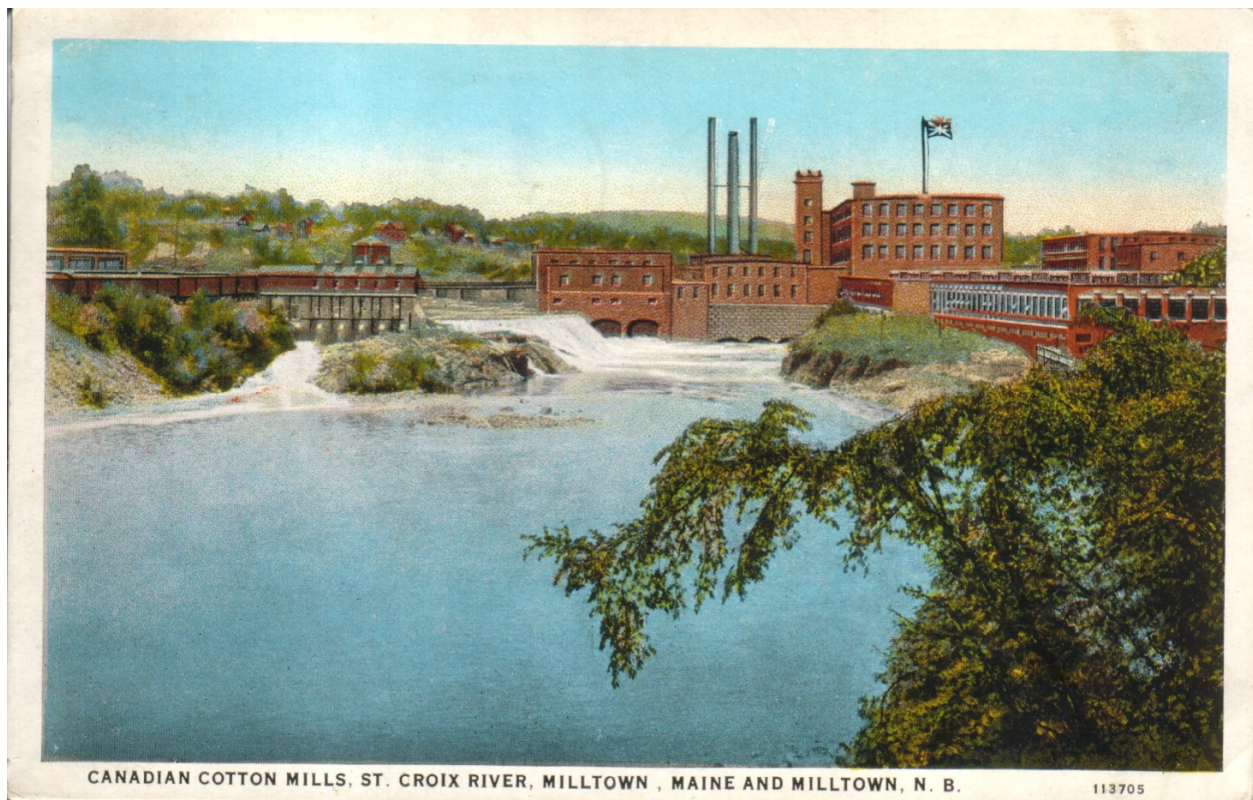
Figure 7: A postcard depicting the St. Croix Cotton Mill, located between Calais, ME, and Milltown, N.B. The current Milltown Dam is the oldest hydroelectric facility in Canada, and was designated a Local Historic Site in 2006. Photo credit: St. Croix Historical Society.

Built in 1881, Milltown Dam, located 1 km from sea just above head of tide in Milltown, N.B., and Calais, ME, presents the first manmade obstacle to fish passage on the St. Croix River (Figure 7). Its hydroelectricity was used to power the looms of the St. Croix Cotton Mill. In 1887, turbine generators brought electricity to the mill and local users (Flagg 2007). The St. Croix Cotton Mill was one of the largest cotton mills in the world, and helped in the early economic development of St. Stephens, N.B. (Flagg 2007; Parks Canada n.d.). Milltown Dam, formerly Cotton Mill Dam, is the oldest hydroelectric facility in Canada, and was designated a Local Historic Place in 2006 (Anonymous 1988; Parks Canada n.d.). Currently owned and operated by New Brunswick Power (NB Power), power generated at 3.9 mw/hr is sold to the grid (FB Environmental 2008). An antiquated fish ladder, dating back to 1960, was replaced with an updated pool-and-weir style fishway in 1980, improving the potential for river herring passage over Milltown Dam (Anonymous 1988). NB Power maintains and operates the fishway on the Canadian shores of the St. Croix River (Table 2).

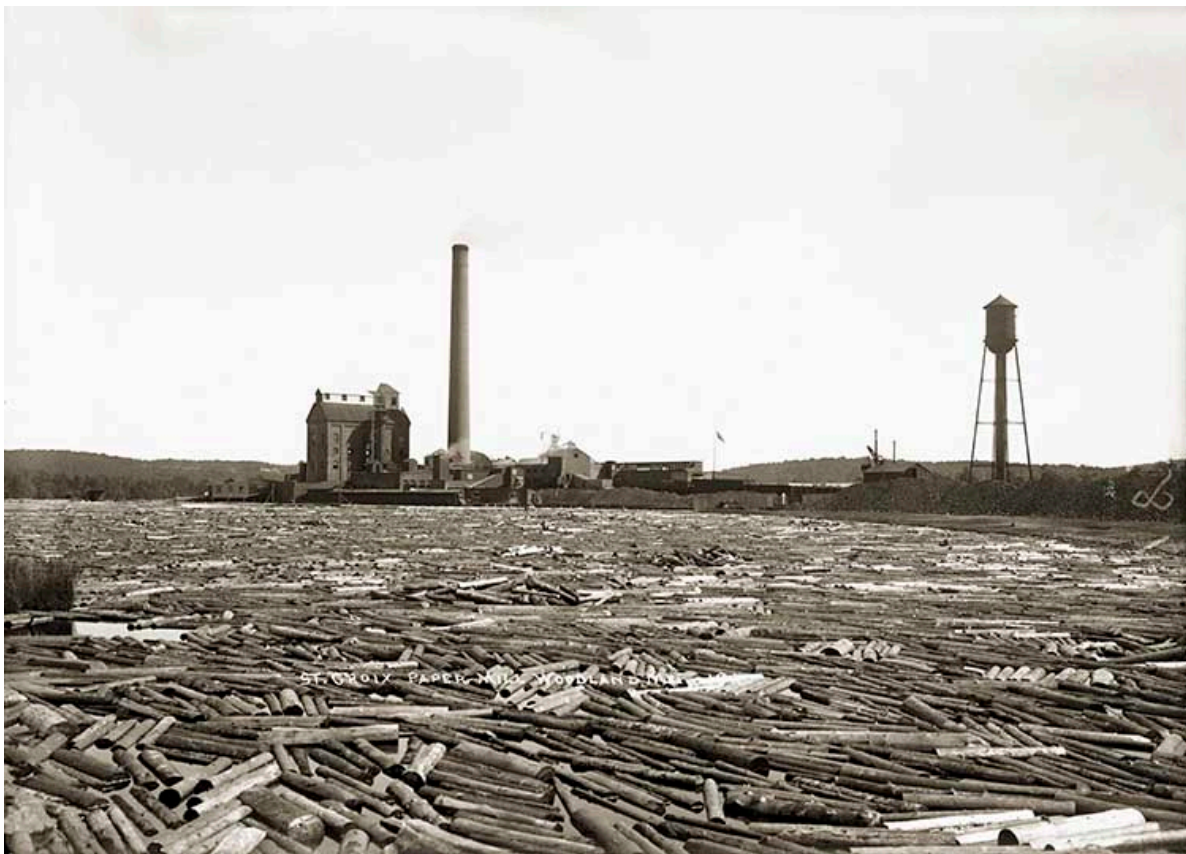
Figure 8: The St. Croix Paper Company. Foreground: The mill pond, holding logs driven downstream after the spring thaw. Background: The Woodland Mill. Photo credit: Penobscot Marine Museum.

Located 14.5 km upstream in Baileyville, ME, Woodland Dam was built in 1906 to house the St. Croix Paper Company (Figure 8; Anonymous 1988). The facilities are currently home to Woodland Pulp, LLC., and St. Croix Tissue, Inc. These self-sufficient operations run entirely on thermal (36 mw/hr) and hydro (11.6 mw/hr) power generation (Kleinschmidt 2015). A 227-m denil style fish ladder was completed in 1965, with no existing fish passage capabilities prior to that time. The ladder, designed to meet safety clearance standards under high voltage power lines traversing the river, is considered one of the longest of its kind worldwide (Anonymous 1988). Woodland Pulp, LLC., is responsible for the maintenance and operation of the fishway (Table 2).

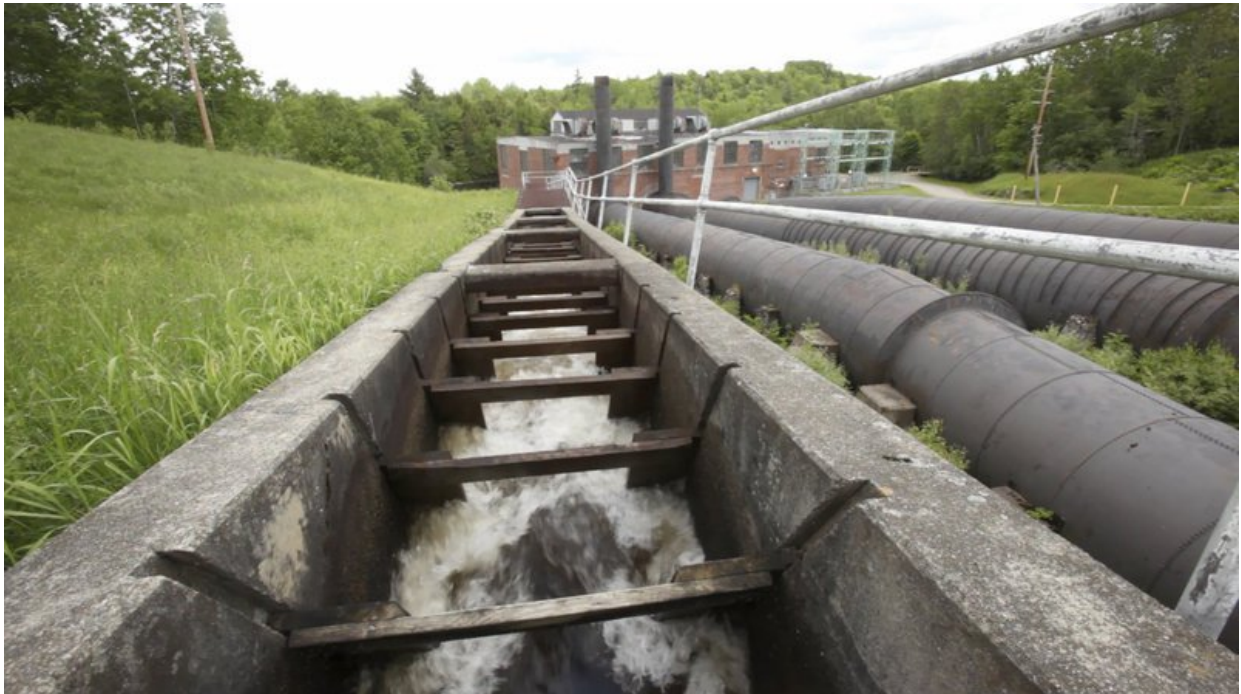
Figure 9: The Grand Falls Dam, looking down from the top of the 182.9-m fish ladder. The Grand Falls and Woodland Dams are owned and operated by Woodland Pulp, LLC., and generate hydroelectricity to power mill and operations. Photo credit: The Portland Herald Press 2012.

Constructed in 1915, 30.6 km upriver in Kellyland, ME, the Grand Falls Dam is the last manmade barrier to fish passage on the main stem of the St. Croix River, prior to its split into the East and West branches (Figure 9). The hydropower facility generates 9.5 mw/hr to power operations at Woodland Pulp, LLC., and St. Croix Tissue, Inc. (FB Environmental 2008; Kleinschmidt 2015). In 1965, construction was completed on a 182.9-m denil style fishway (Anonymous 1988). Woodland Pulp, LLC., is responsible for the maintenance and operation of the fishway at Grand Falls Dam (Table 2).
