# Operation of the Lake Erie - Niagara River Ice Boom

A report to the  
International Niagara Board of Control  
by the  
International Niagara Working Committee

September 2005

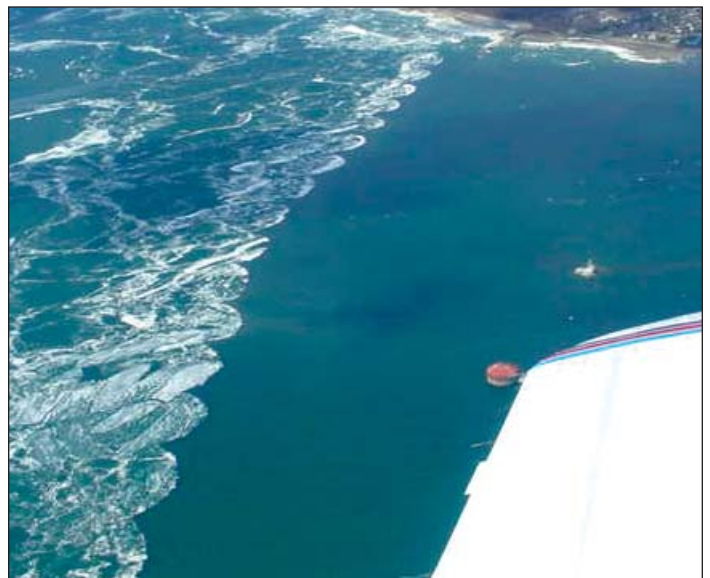
Ice Thickness Measurements - 15 February 2005

A helicopter flight to measure the ice thickness at six pre-selected or standard sites in the eastern part of Lake Erie was conducted on 15 February. Due to predominantly open water conditions, only one test site was sampled. This was an alternate site east of the standard site number 2 as shown on the map above. The thickness at this site was 25 centimetres (10 inches). By comparison, similar measurements taken on 16 February 2004

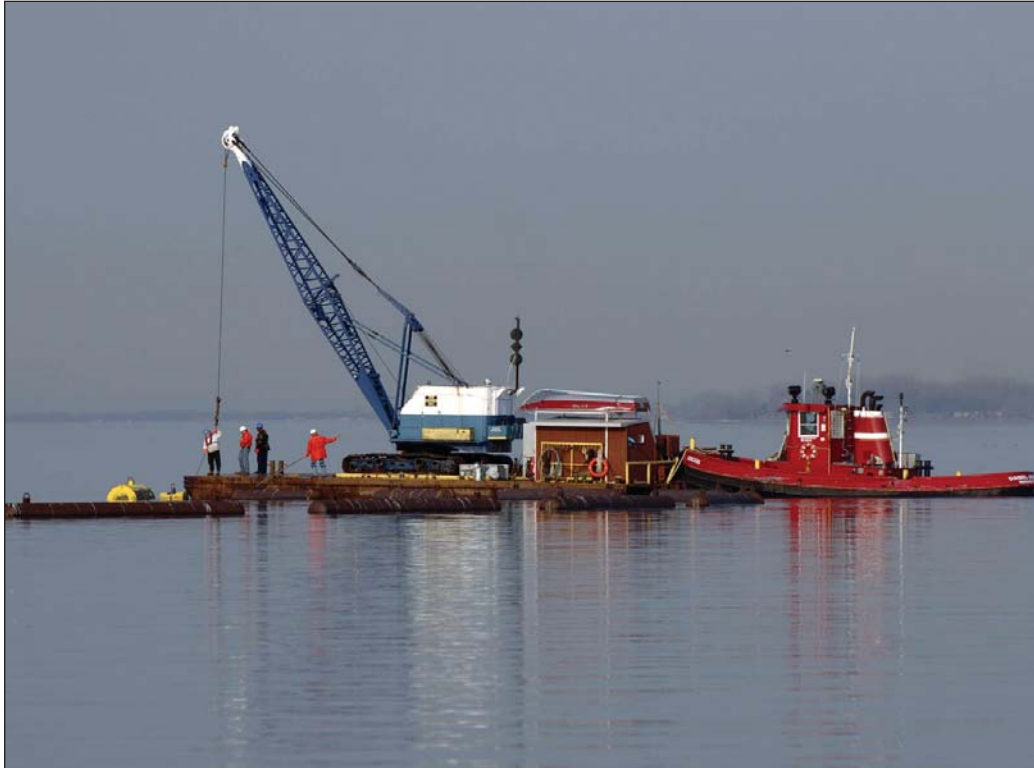
Rankine Power Plant, located in Canada, diverts water from the Cascade area and returns it to the Maid-of-the-Mist-Pool. The Rankine Plant is located just upstream of the Horseshoe Falls. Figure 4 shows the location of these diversion structures and hydro-electric power plants.

A major portion of the Lake Erie outflow is utilized for power production and is diverted to hydro-electric plants by intake structures located above the Falls (Figure 4). A lesser portion is diverted for power via the Welland Canal. The high head plants, Sir Adam Beck Nos. 1 and 2 in Canada and the Robert Moses Niagara Power Project in the United States, withdraw water from the Chippawa-Grass Island Pool and return it to the lower Niagara River at Queenston, Ontario and Lewiston, New York, respectively. Fortis Ontario's

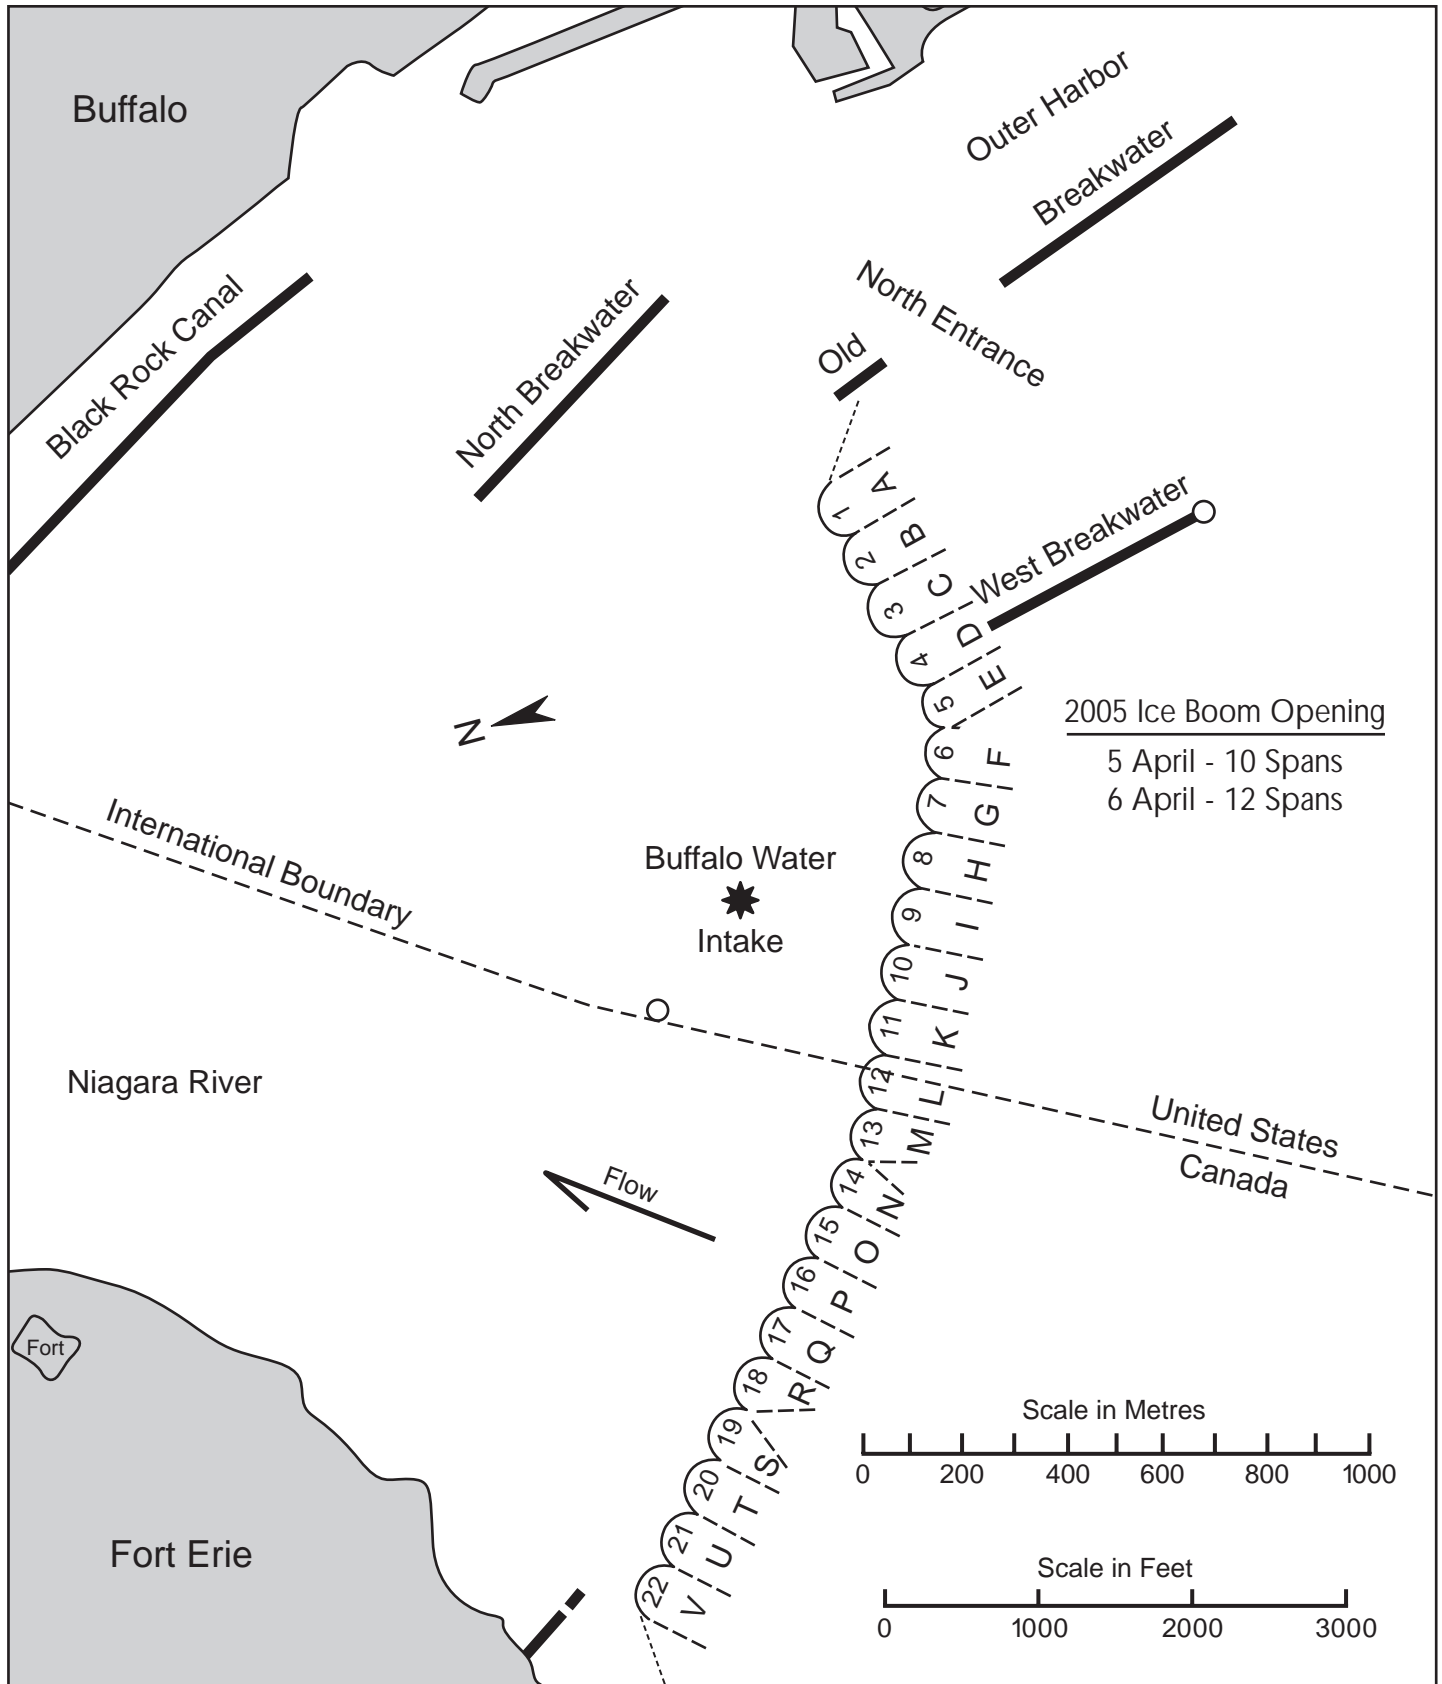
FIGURE 1

Plan View of Ice Boom and Sequence of Removal

Based on experience gained during the 1997-1998 ice season, it was recommended that, in order to reduce the potential for damage to the ends of the pontoons from collisions due to storm induced wave action during open water periods, one steel pontoon from each of spans A through J of the ice boom be removed. Therefore, spans A through J contain 10 instead of 11 steel pontoons beginning with the 1998-1999 ice season. This modification greatly reduced damage to the pontoons in this reach. A map of eastern Lake Erie showing the location of the ice boom is included as Figure 5. Figure 6 is a map of the upper Niagara River. Figure 7 illustrates structural details and a plan view of the ice boom.

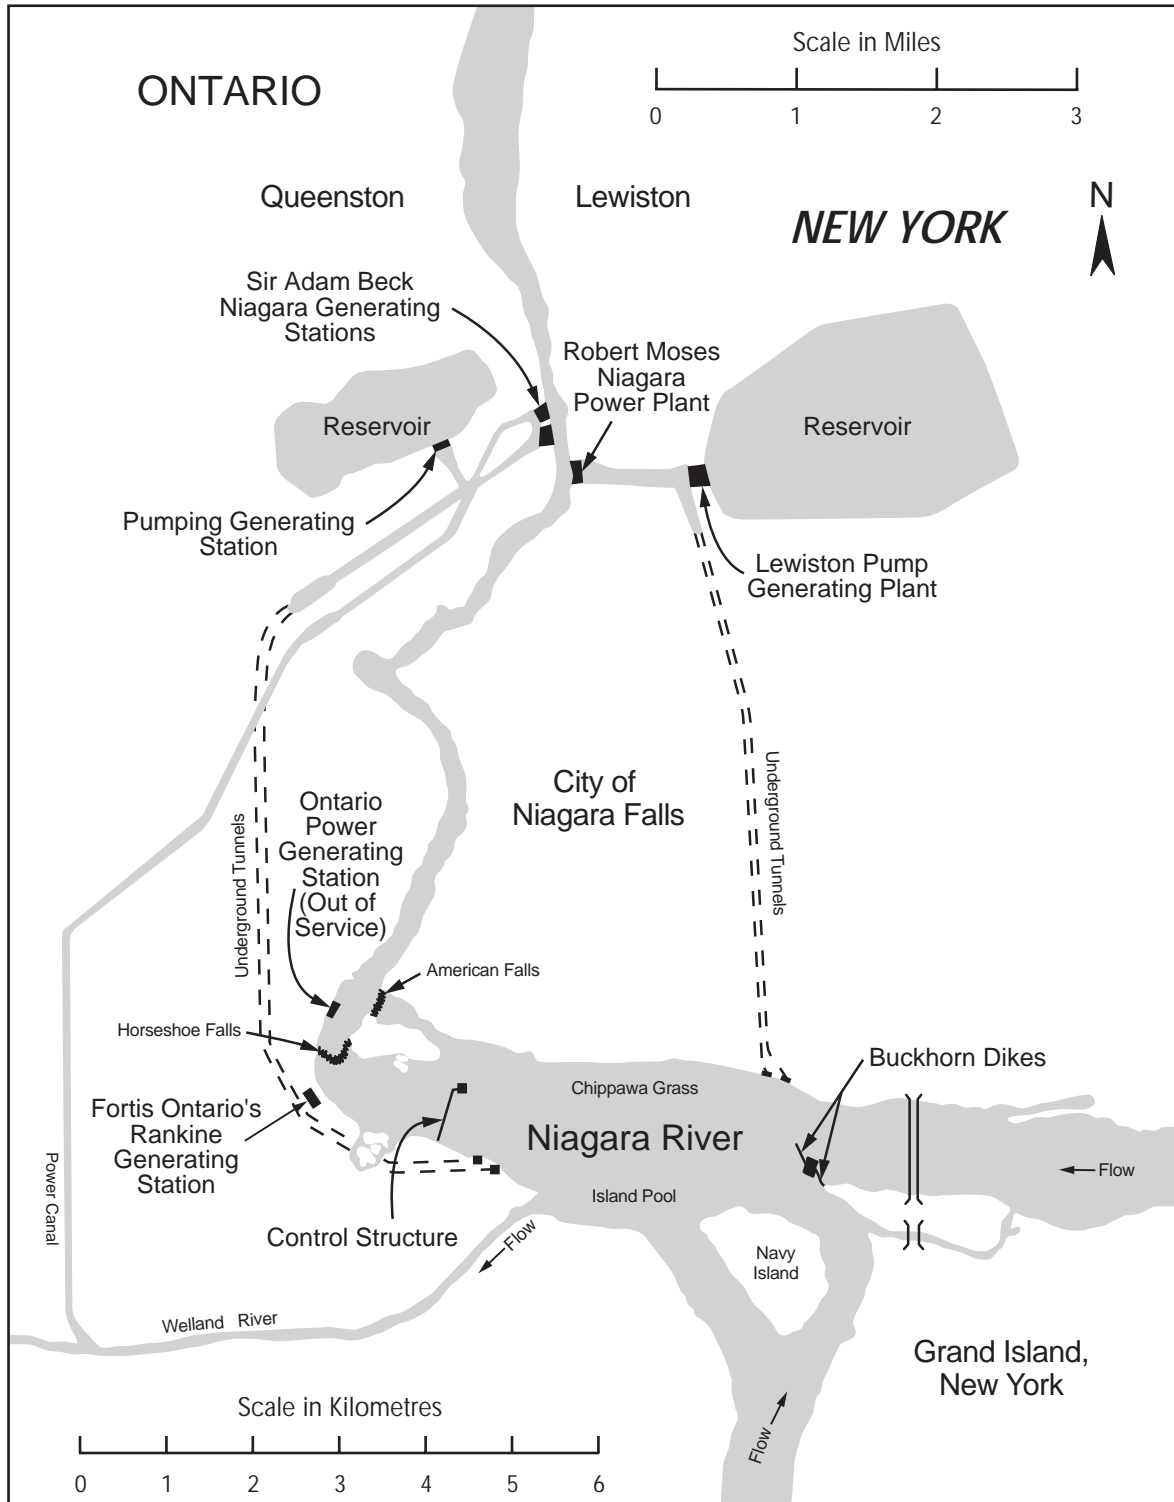
FIGURE 4

# Niagara River Diversion Structures and Power Plants
